**Subject: CLEARANCE REPORT:
Visual Inspection to Evaluate Work Performance
POST- Paint Removal at Building 15 South Elevation**

Site Address: Rainier Commons
3100 Airport Way S
Seattle WA

NVL Project #: 2012-494

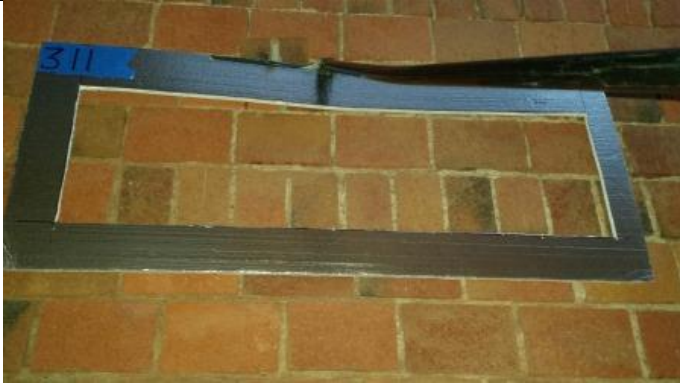
Random Count #	Grid #	Photograph	Paint Still Present?
5 093352	311

No
6 093649	338

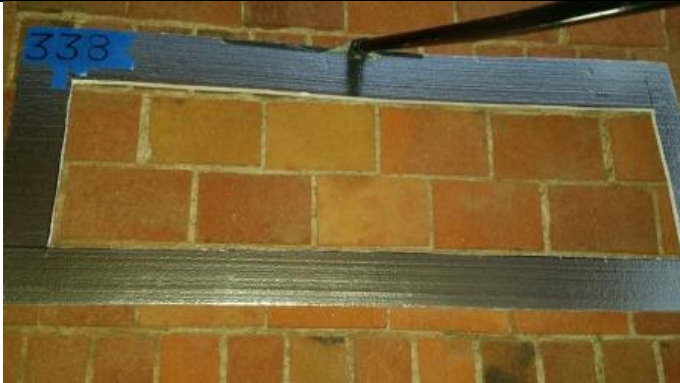
No
7 091212	340

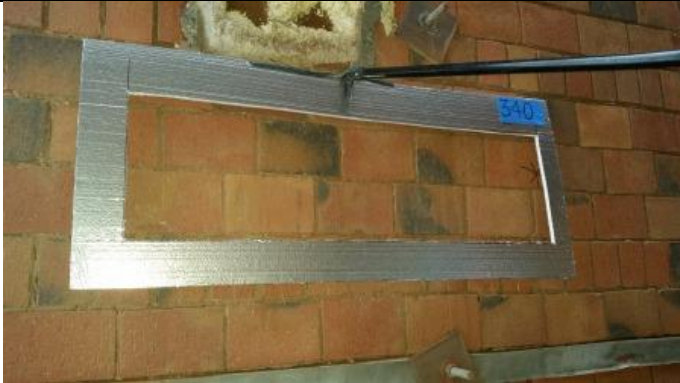
No
8 092706	356

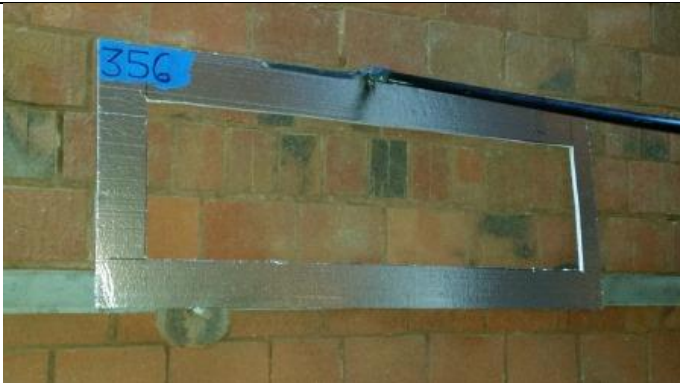
No

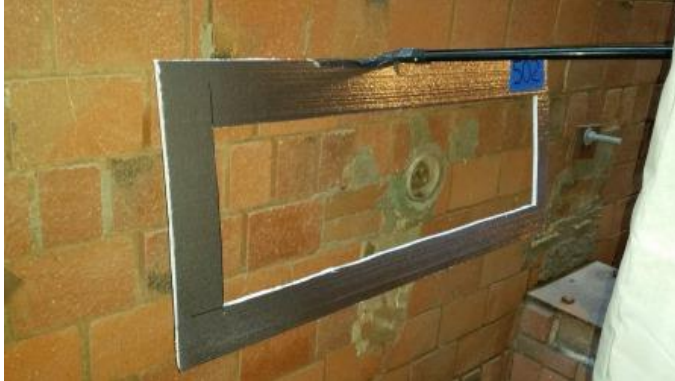
Random Count #	Grid #	Photograph	Paint Still Present?
13 091708	502

No
14 095503	673

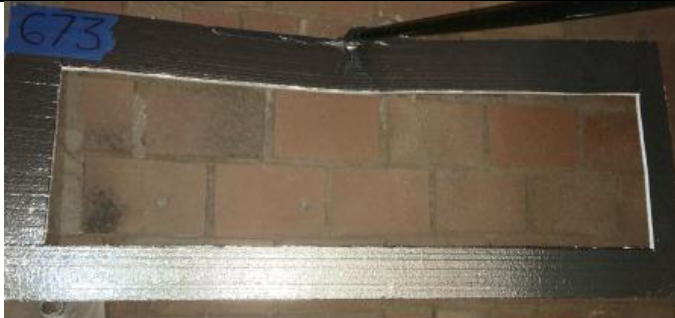
No
15 095830	702
